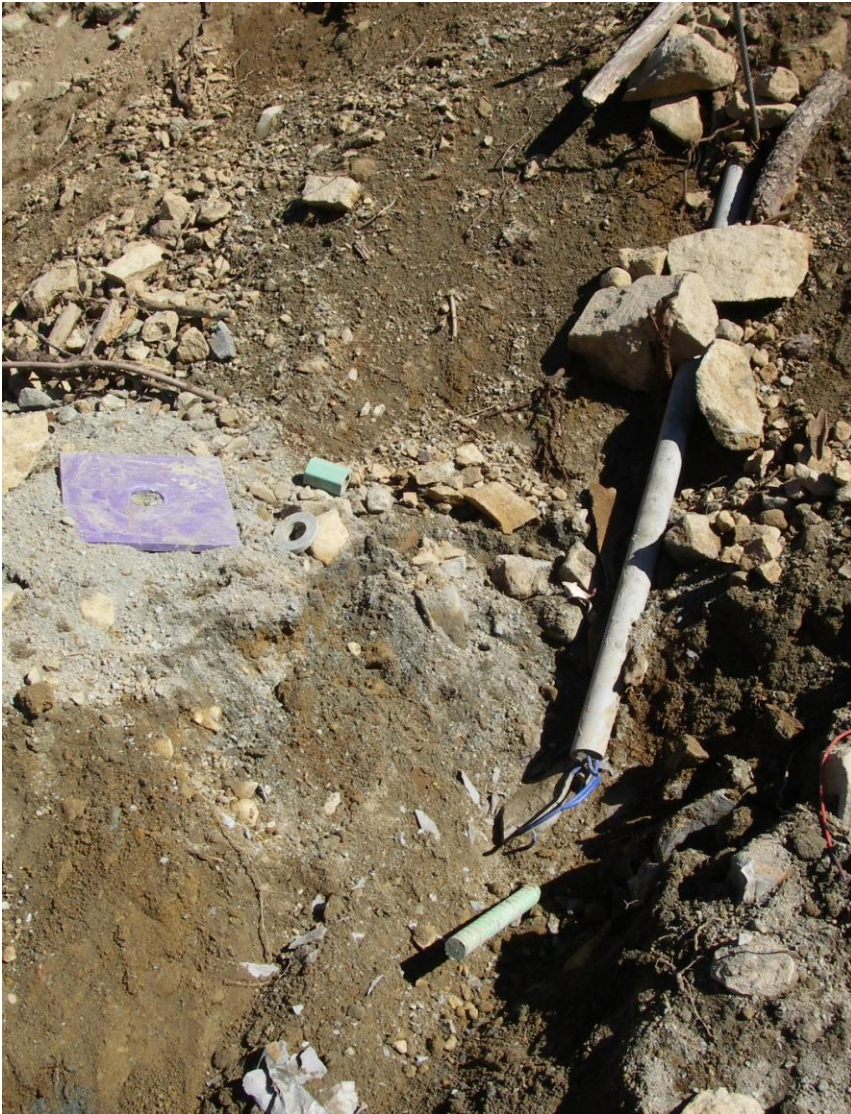
Figure 1a: Damaged grout and cables at sensor D-2.

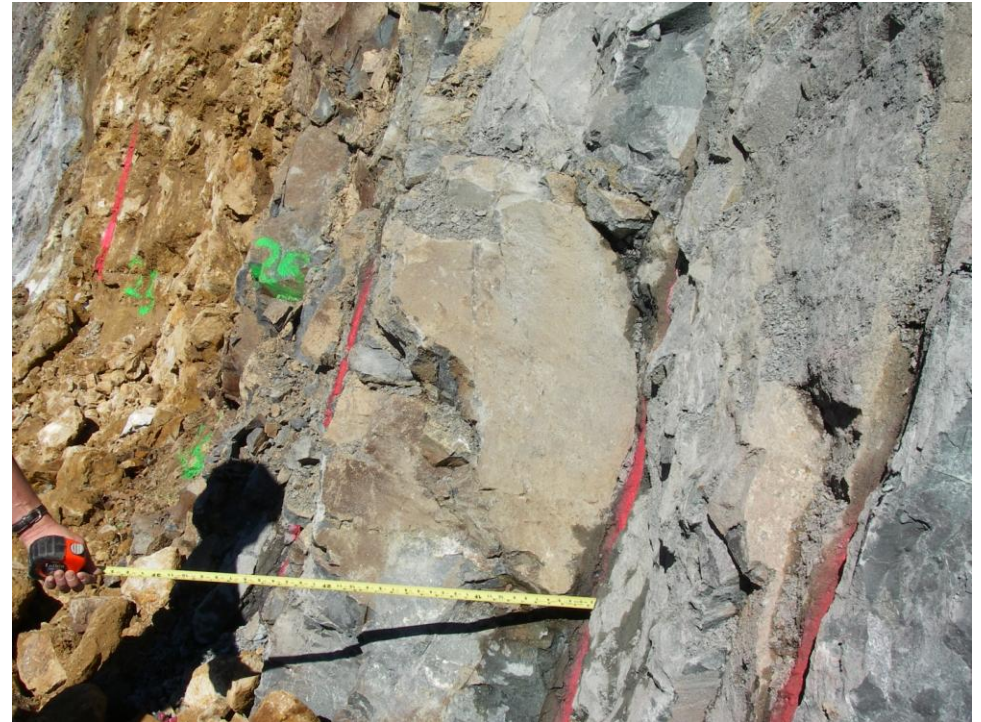
Figure 1b: View of irregular pre-split near Sta. 1326+00.
